PHOTOGRAPHIC INTELLIGENCE REPORT

OF THE MARK II AND MARK III GUIDELINE MISSILE

CIA/PIR -71023

DATE FEBRUARY 1967

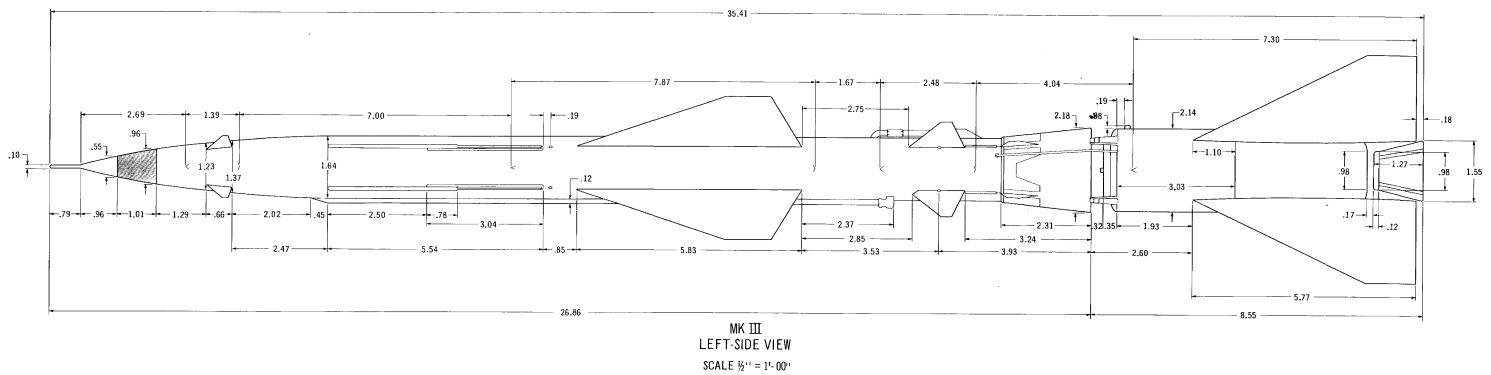
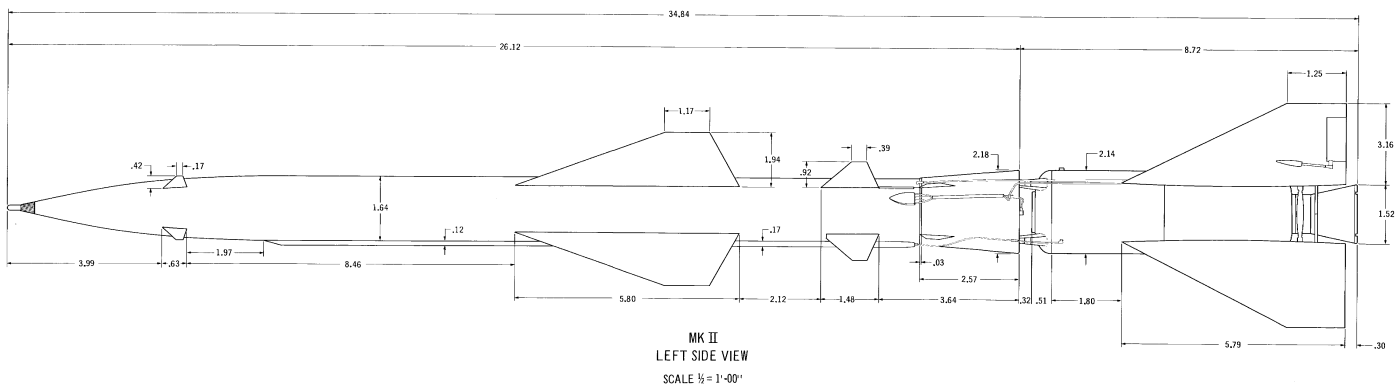
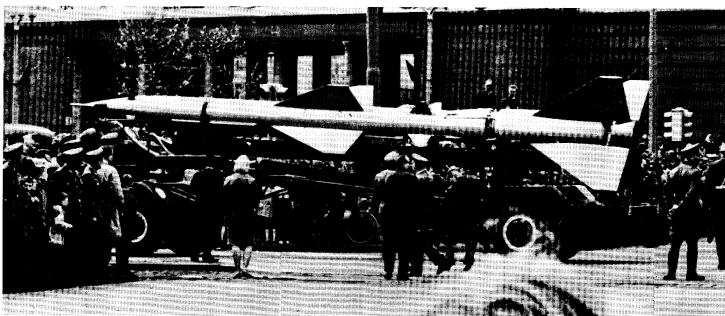
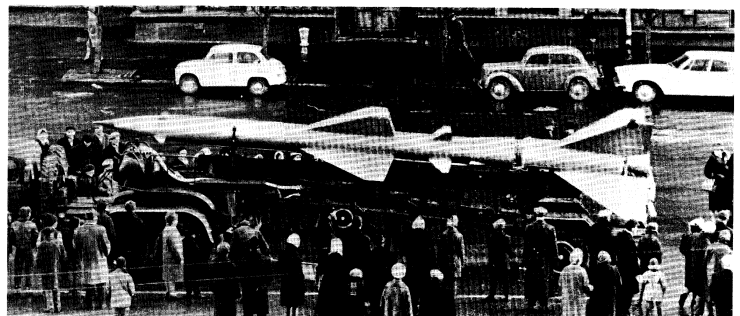
FIGURE 1. LEFT-SIDE VIEW COMPARISON OF THE MK III AND MK II GUIDELINE MISSILES.

1. The probe on the Mark III is longer than the observed portion of the probe on the Mark II, and appears to be fixed in that position (Figure 1).
2. A probable antenna, in the form of a dark band, is located on the ogive section, forward of the canards on the Mark III.

8. Only one line connects the sustainer with the booster on the Mark III and this is located on the upper left side. It extends from a point just in front of the thrust structure, across the thrust structure, and joins the booster at a point immediately below the upper left sustainer/booster connecting lug (Figure 1).

13. The booster nozzle on the Mark II has a nozzle throat adjustment device, which is not present on the Mark III missile. The nozzles on each missile differ in size as well (Figures 1 and 10).

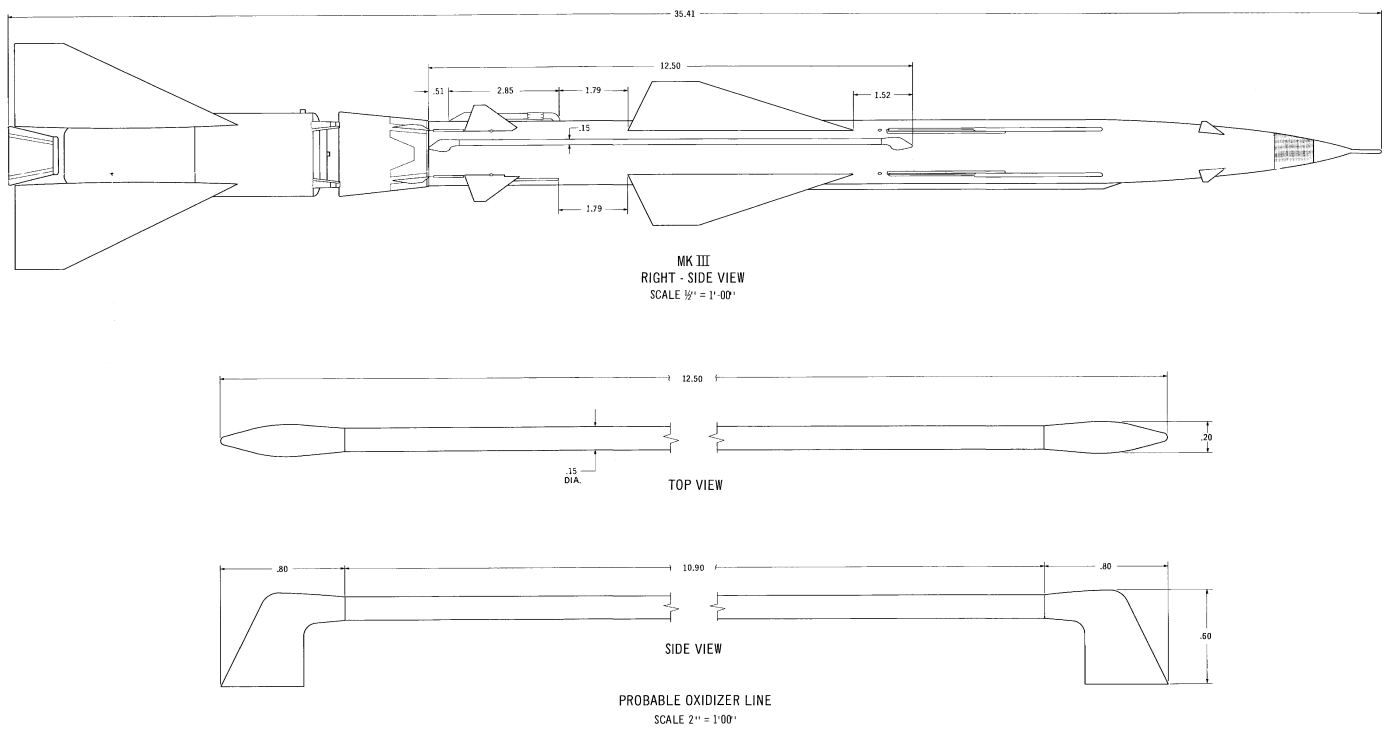
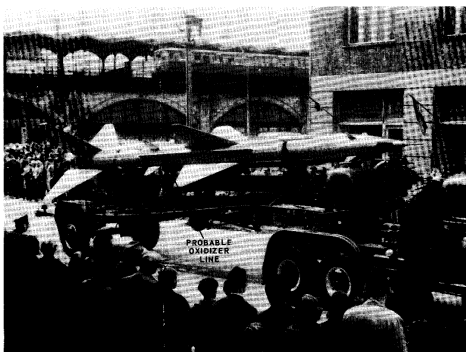
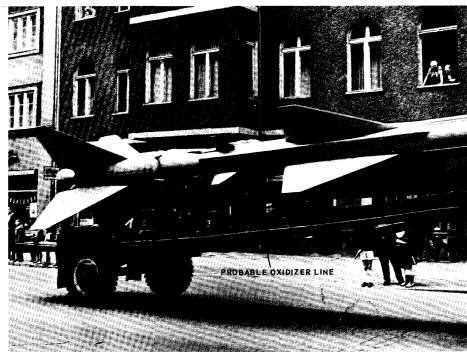
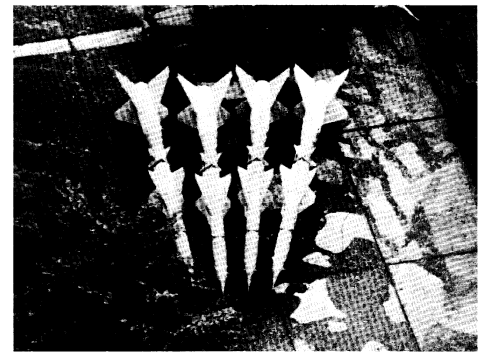
FIGURE 2. RIGHT-SIDE VIEWS OF THE MK III GUIDELINE MISSILE AND PROBABLE OXIDIZER LINE.

4. A probable oxidizer line 12.5 feet in length, runs along the right side of the Mark III sustainer from a point just forward of the sustainer wings to just aft of the control surfaces (Figure 2). As shown in Figures 2 and 3, this line protrudes from the missile body 0.6 feet. The degree of accuracy for this measurement cannot be determined due to the angle of the photography used for mensuration. It can be determined, however, that this line is not attached to the missile body except at either end, where it enters the sustainer. The only protrusions on the Mark II sustainer, in relatively the same location, are two small possible antennas located between the control surfaces and the sustainer wings.

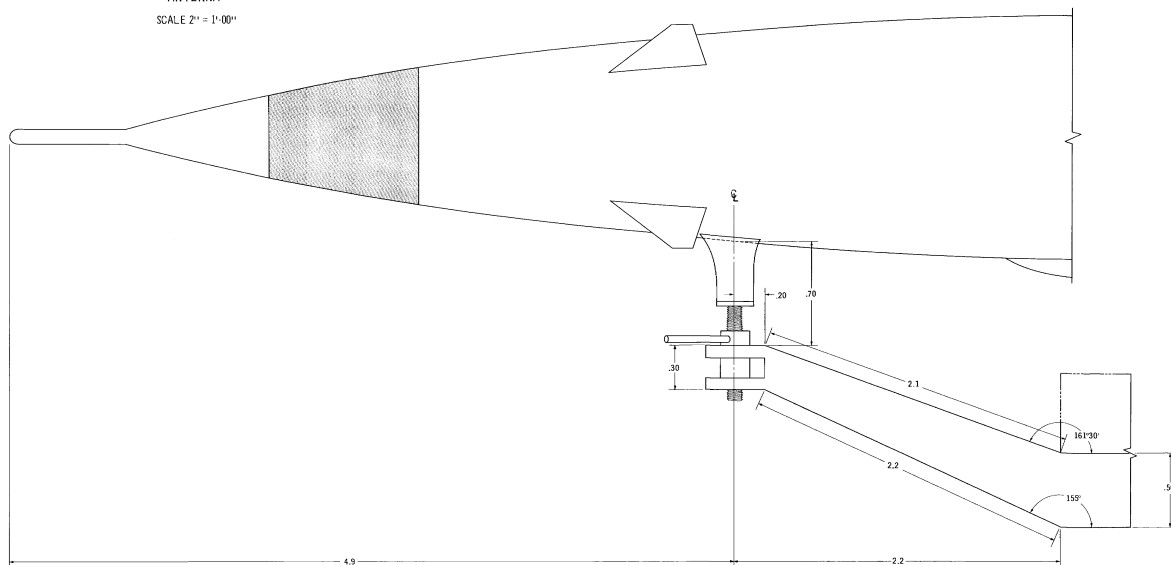
MK III TRANSPORTER MISSILE SUPPORT ARM
SCALE 2" = 1'-00"

FIGURE 4. MK III GUIDELINE MISSILE ANTENNA, CANARD, AND TRANSPORTER MISSILE SUPPORT ARM.

3. A probable antenna is located just forward of, and in line with, each sustainer wing on the Mark III (Figure 4). No antennas are present on this portion of the Mark II.

Two apparent changes were made to the Mark II missile transporter trailer in order to accommodate the Mark III missile. One change was the addition of an arm which extends from the front of the missile support rail and supports the forward portion of the Mark III sustainer (Figure 4). The point of support is directly behind the canards. The second change to the transporter was the enlarging of the oxidizer tank located on the forward portion of the transporter (Figure 3). The tank on the Mark II transporter was approximately 1.64 feet in diameter. On the Mark III transporter, the tank is located in the same relative position, however, it is 2.36 feet in diameter and 6.99 feet in length overall. Because of the quality of the photography used in the mensuration of the Mark III transporter oxidizer tank, the accuracy is limited to ± 10 percent.

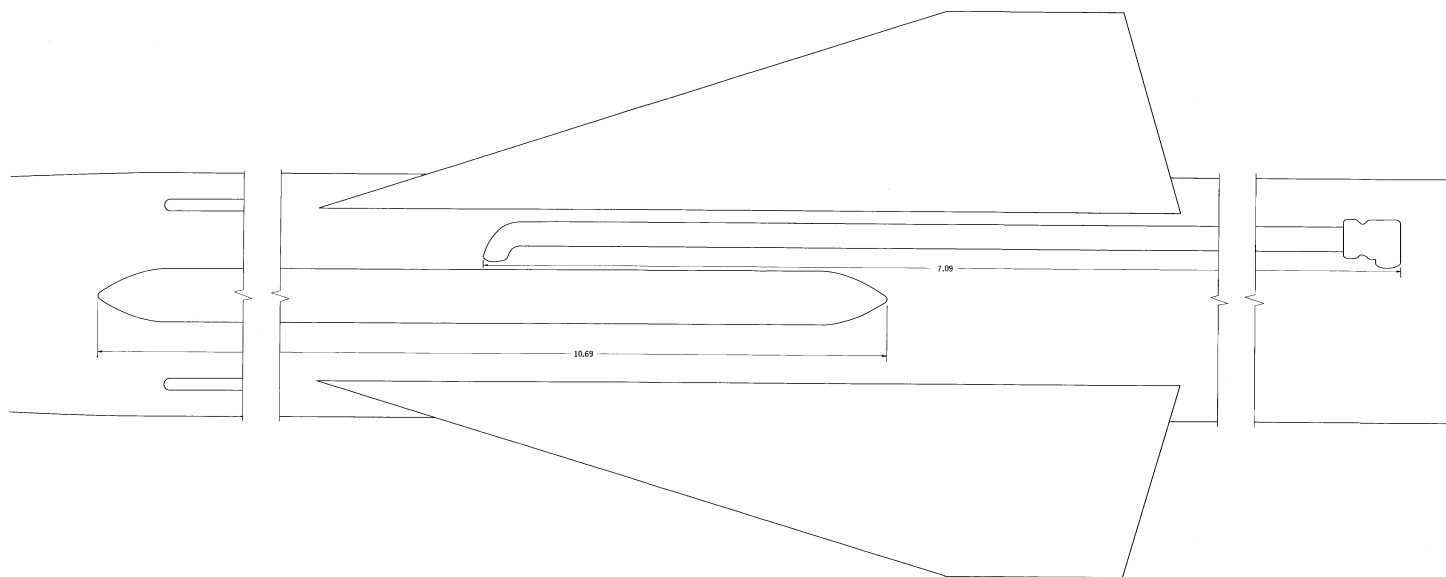
PROBABLE FUEL LINE LOWER LEFT

FIGURE 5. BOTTOM VIEWS OF THE MK III GUIDELINE MISSILE SUSTAINER.

7. One external line is located in the same position on the Mark II and the Mark III GUIDELINES. On both missiles it is located under the lower left sustainer wing (Figure 5). There is a difference, however, in the manner in which this line terminates. On the Mark III it passes directly into the sustainer at a point 2.37 feet behind the sustainer wing, while on the Mark II the line extends further aft and is joined by a smaller pipe or tube which in turn passes across the thrust structure and attaches to the booster. On the Mark III this line is 7.09 feet in length, but because of the photography used in the mensuration, this measurement can be considered accurate only to within $\pm .15$ feet.

10. There is a fairing along the bottom of the Mark III sustainer, which is 10.69 feet in length. The accuracy of this dimension is limited to $\pm .15$ feet, due

to the photography used for the mensuration (Figure 5). A similar fairing is present along the bottom of the Mark II sustainer.

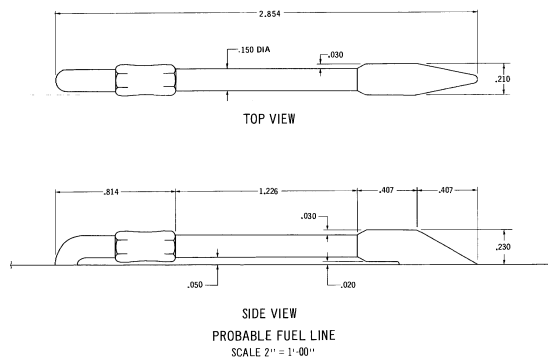
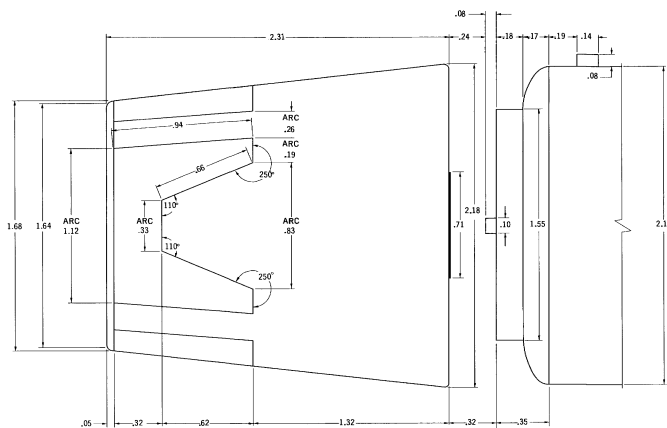
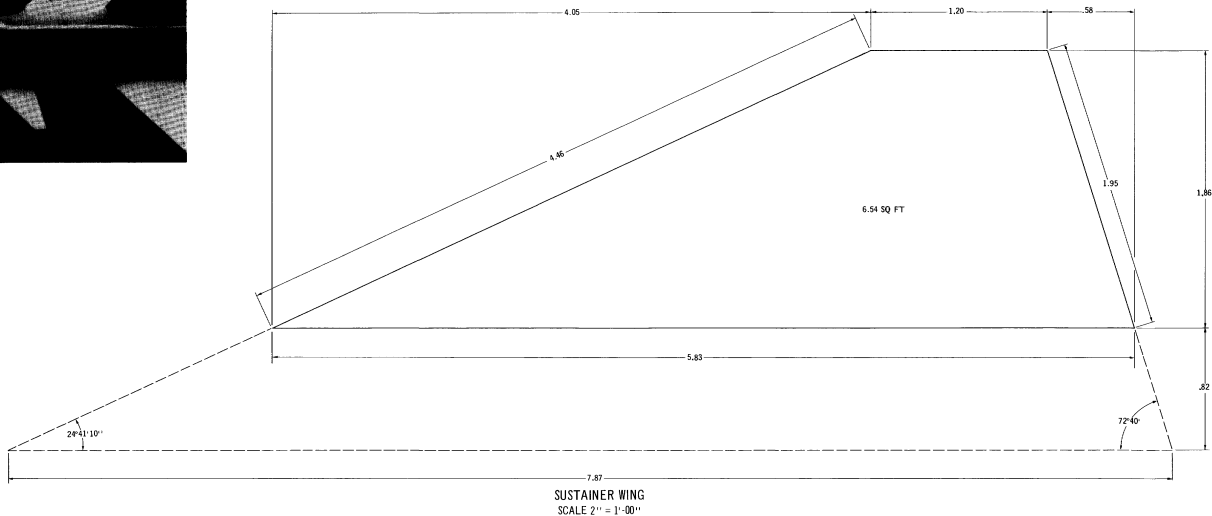
THRUST STRUCTURE
SCALE 2" = 1'-00"

SUSTAINER WING
SCALE 2" = 1'-00"

FIGURE 6. MK III GUIDELINE MISSILE THRUST STRUCTURE, SUSTAINER WING, AND AFT FUEL LINE.

6. A probable fuel line runs midway between the upper right and upper left control surfaces. It extends from just forward of, to just aft of, the control surfaces themselves (Figure 6).

11. The thrust structure of the Mark III is slightly shorter than that of the Mark II and has been reinforced (Figure 6). The outline of a reinforcing skirt can be identified on the forward portion of the thrust structure. The thickness of this reinforcing skirt is estimated to be .002 of a foot.

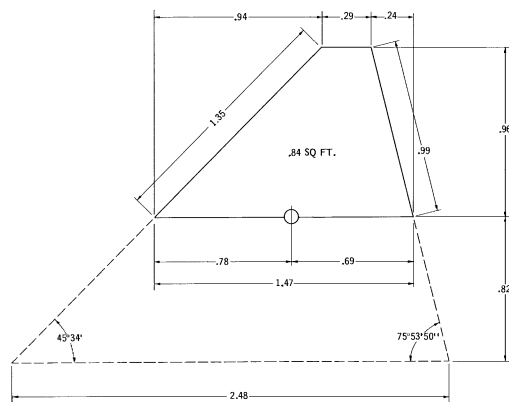
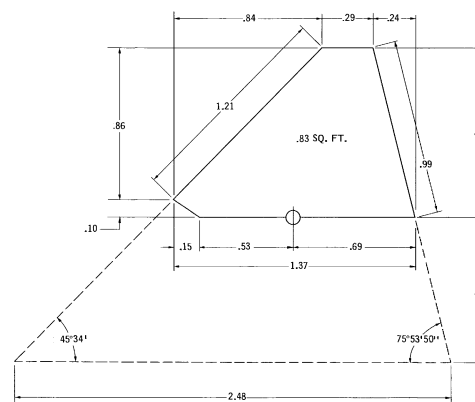
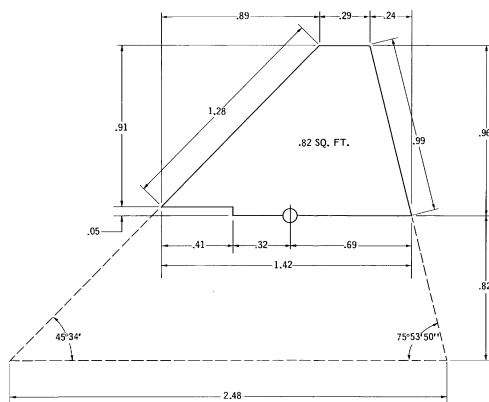
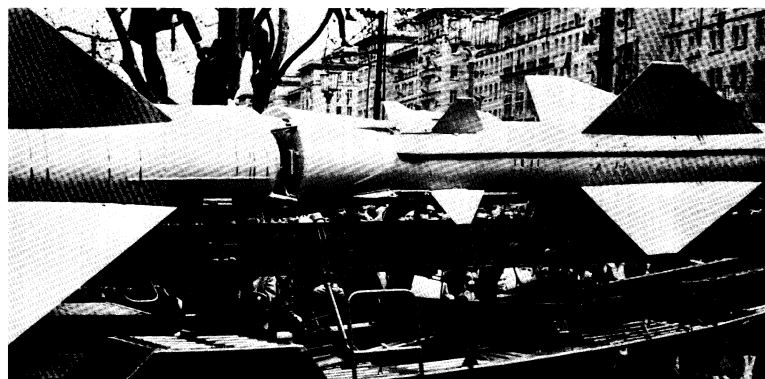
UPPER LEFT CONTROL SURFACE
SCALE 2" = 1'-00"

UPPER RIGHT AND LOWER LEFT CONTROL SURFACES
SCALE 2" = 1'-00"

LOWER RIGHT CONTROL SURFACE
SCALE 2" = 1'-00"

FIGURE 7. MK III GUIDELINE MISSILE CONTROL SURFACES.

5. The control surfaces and their associated locking devices have changed on the Mark III, from those on the Mark II (Figures 7 and 8). Of the four control surfaces of the Mark III, two of them (upper right and lower left) are identical. The remaining two differ in configuration from those mentioned and also differ from

each other. On the Mark III, a locking device is present with each of the four control surfaces, whereas on the Mark II the lower left control surfaces does not have a locking device associated. Also on the Mark III, wing nuts are used to secure the locking devices, and no such wing nuts are present on the Mark II.

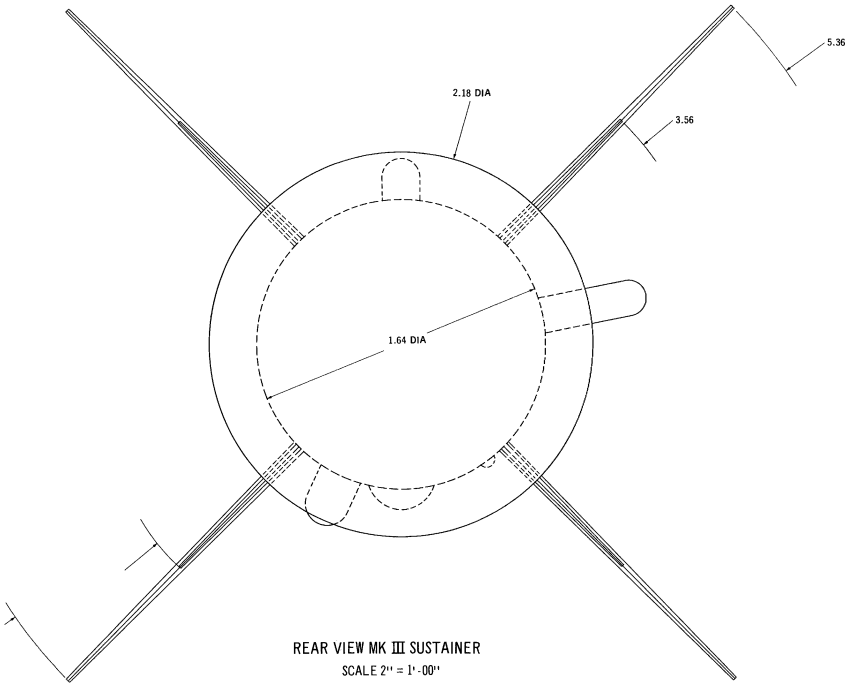
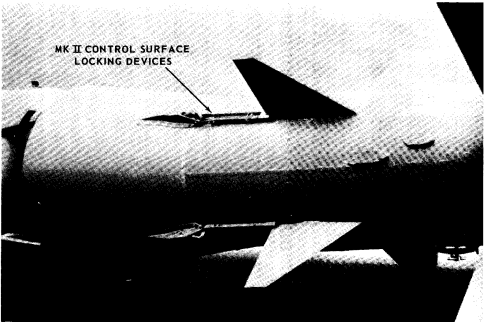
FIGURE 8. MK III GUIDELINE MISSILE SUSTAINER AND COMPARISON OF THE MK III AND MK II CONTROL SURFACE LOCKING DEVICES.

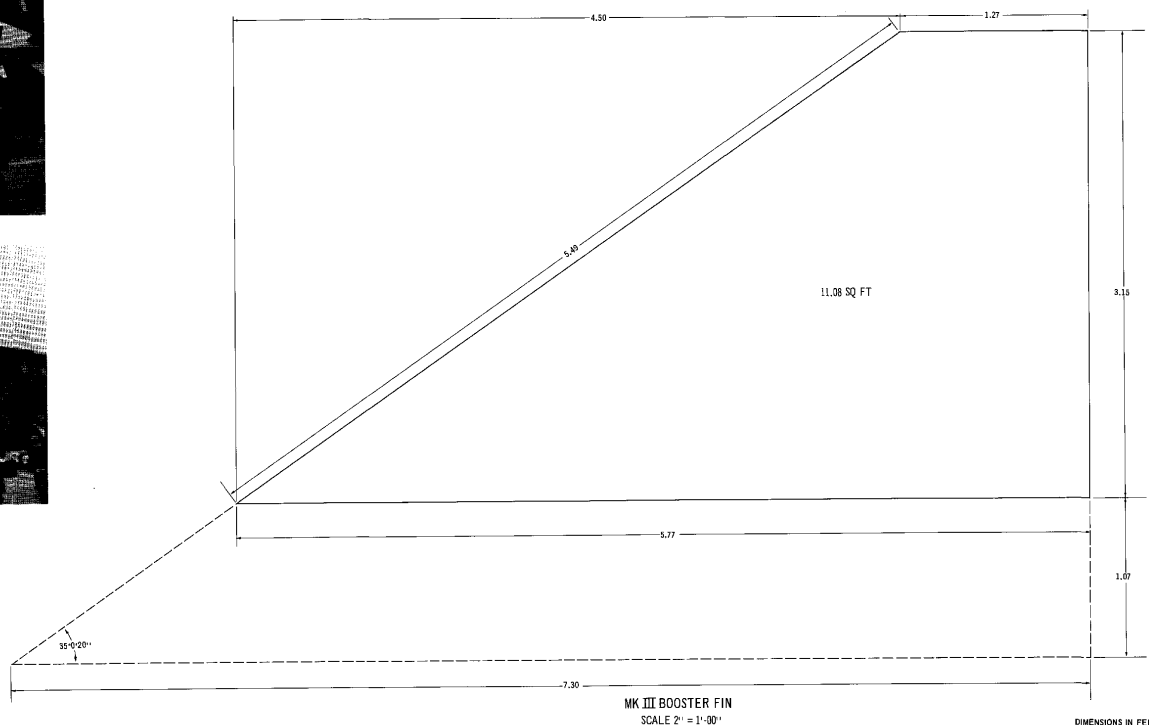
FIGURE 9. COMPARISON OF THE MK III AND MK II GUIDELINE MISSILE BOOSTERS.

12. The booster itself is primarily the same on both the Mark II and III, however there are changes in the booster fins and the nozzle (Figure 9). On the Mark II the upper left and lower right booster fins have control surfaces. Associated with these control surfaces are the activating rods which can be seen around the booster nozzle, and the probable pneumatic tube described above. No control surfaces or associated components are present on the Mark III booster fins.

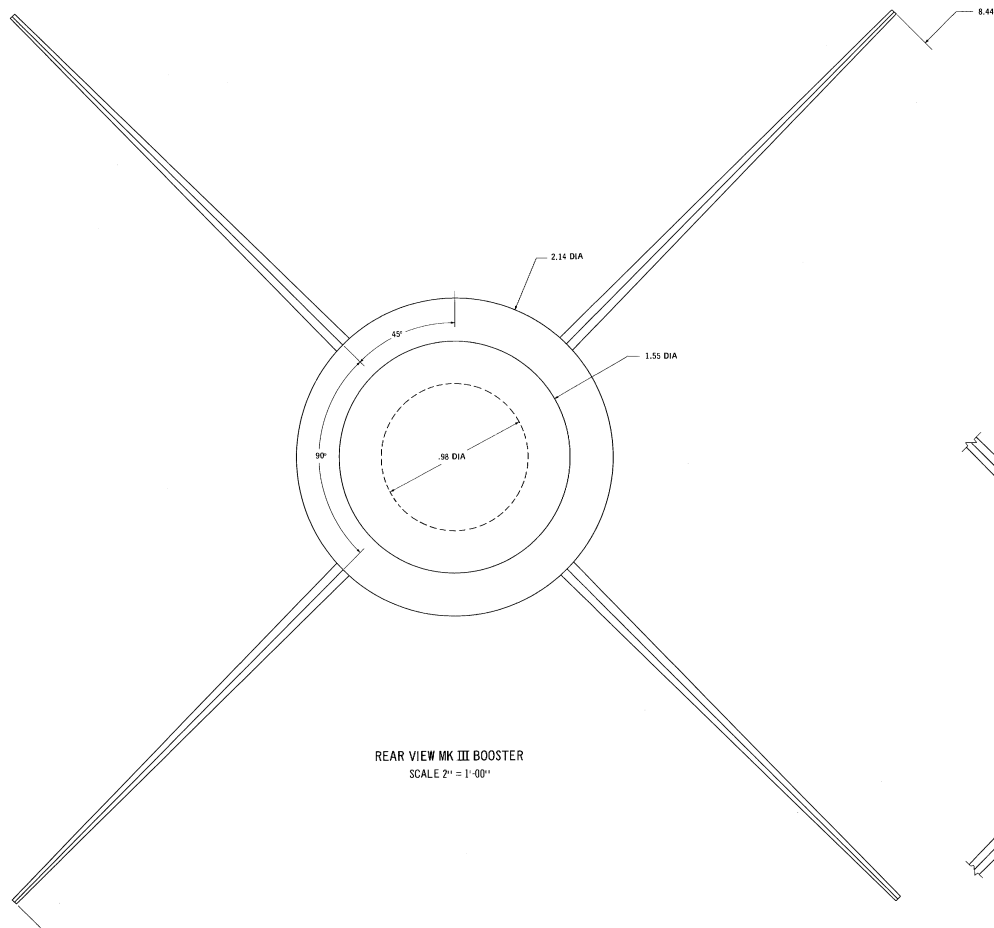
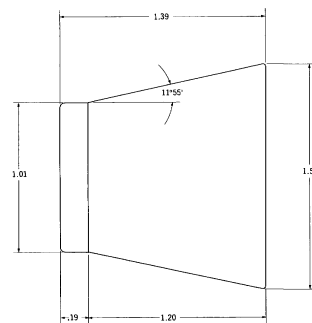
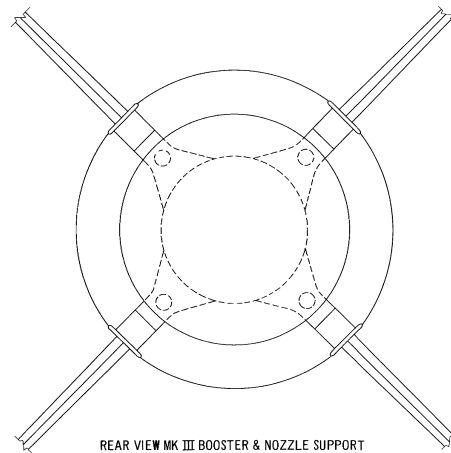
REAR VIEW MK III BOOSTER
SCALE 2" = 1'-00"

MK II BOOSTER NOZZLE
SCALE 2" = 1'-00"

REAR VIEW MK III BOOSTER & NOZZLE SUPPORT

FIGURE 10. MK III GUIDELINE MISSILE BOOSTER AND NOZZLE SUPPORT AND MK II BOOSTER NOZZLE.
